NASA Technical Memorandum 85831

**FIELD REPAIR OF AH-1G HELICOPTER
WINDOW CUTTING ASSEMBLIES**

Laurence J. Bement

May 1984

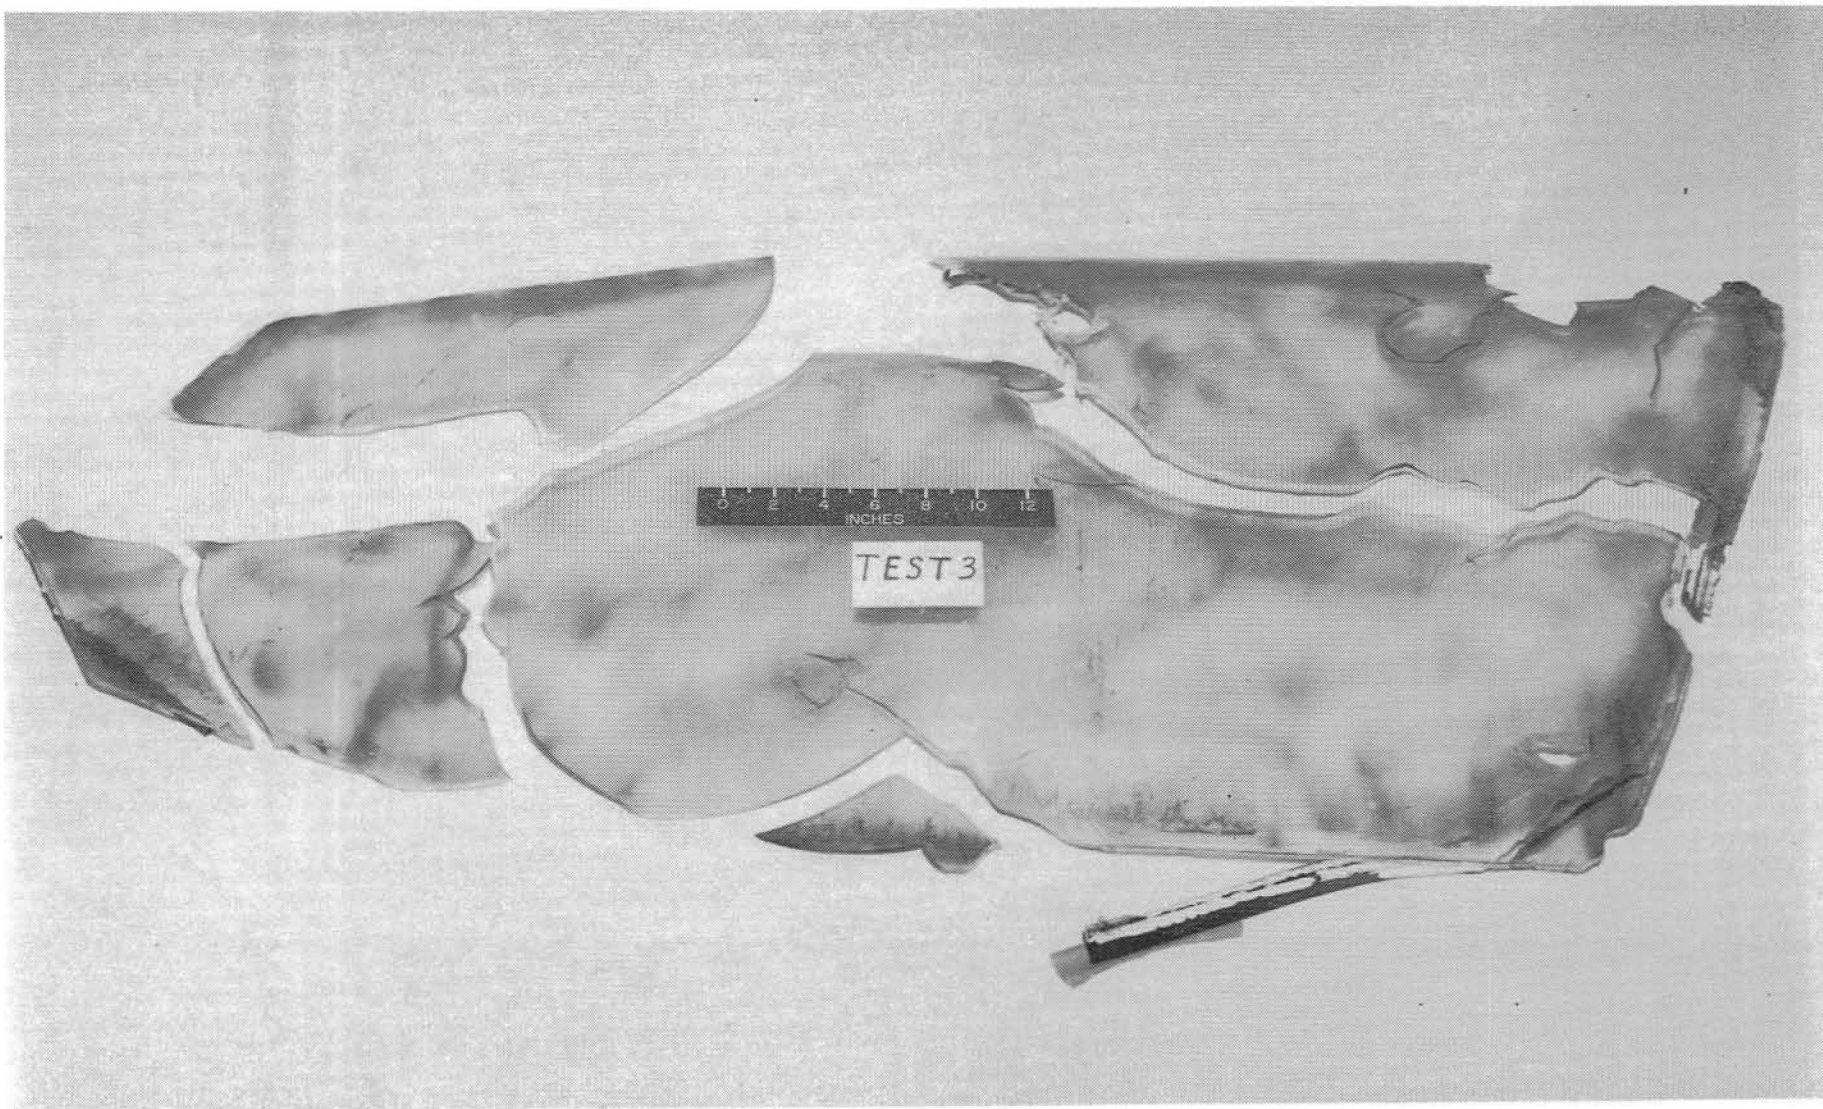
Figure 15.- Acrylic pushed out of the frame in Test 3. The only portion not severed was the small piece, bottom center. Also attached on the bottom is a portion of the window cutting assembly extrusion and frame.

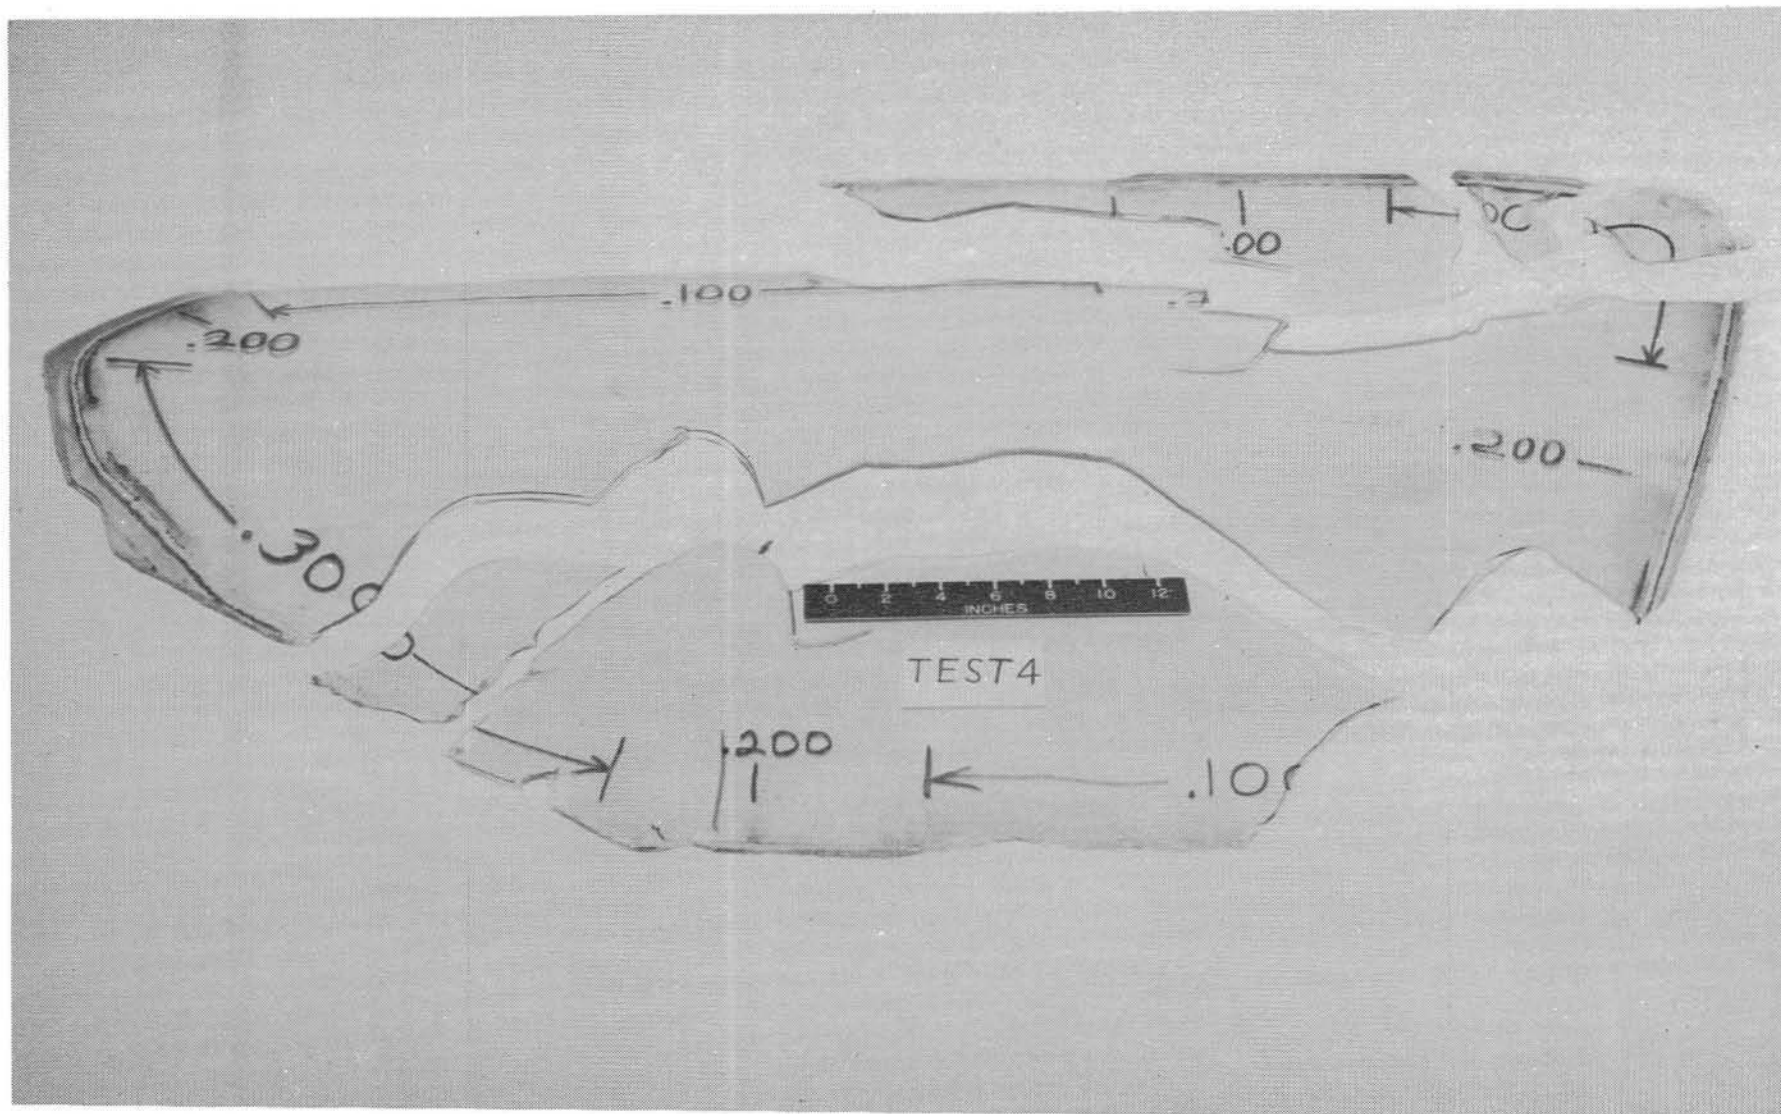
left areas, shown in fig. 14). The two remaining areas required approximately 100 pounds to push out. The entire periphery was severed at the acrylic-to-frame interface. The areas hinged on the RTV bond line, and in most cases the window cutting assembly frame was broken to clear the area. The pushed-out area for test 3 is shown in figure 15. A 125-pound thrust released the major area. The periphery was 98 percent severed at the acrylic-to-frame interface; an 8-inch length in the lower, center area was not severed. The remaining areas required thrusts of 90, 30, and 85 pounds to clear more than 95 percent of the area. For test 4 with the closely controlled RTV installation, no more than 4 pounds was necessary to push out any portion of the acrylic. The acrylic was severed around the entire periphery. The RTV bonds were all that retained the acrylic in position. Figure 16 shows the pushed-out acrylic.

Figure 16.- Acrylic pushed out of the frame in Test 4. The missing section at the lower right had fallen out during the firing. See Figure 11.
